# ROCK SOLID

1230 Sample Report Drive, Greensboro, GA 30642  
Inspection prepared for: Sample Report  
Real Estate Agent: Your Agent -

Date of Inspection: 5/13/2016 Time: 9:00 AM  
Age of Home: 15 Size: 4051

## Home Inspection Report

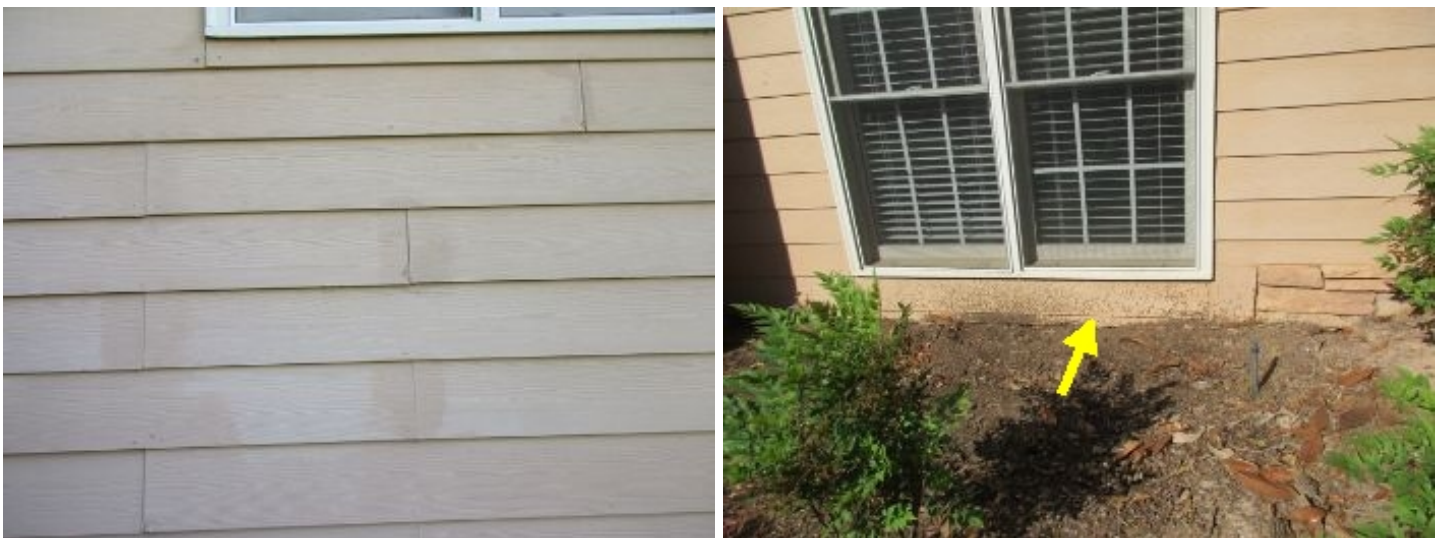
1.1. Monitor: Wood/soil contact at the base of the siding should be eliminated. These areas are at risk of additional hidden damage, recommend 6 to 8 inches of clearance from the siding to finish grade.

1.2. Repair: The siding is lacking proper sealant joints at intersections of dissimilar materials. This condition should be repaired to help prevent moisture intrusion. (Brick meets wood, stucco meets wood or brick, window or trim intersections, etc.)

1.3. Repair: The siding is lacking maintenance. Recommend caulk and painting.

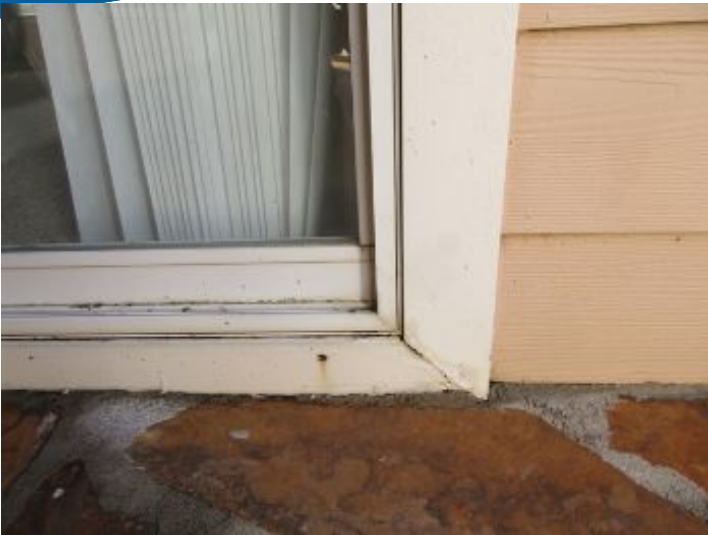
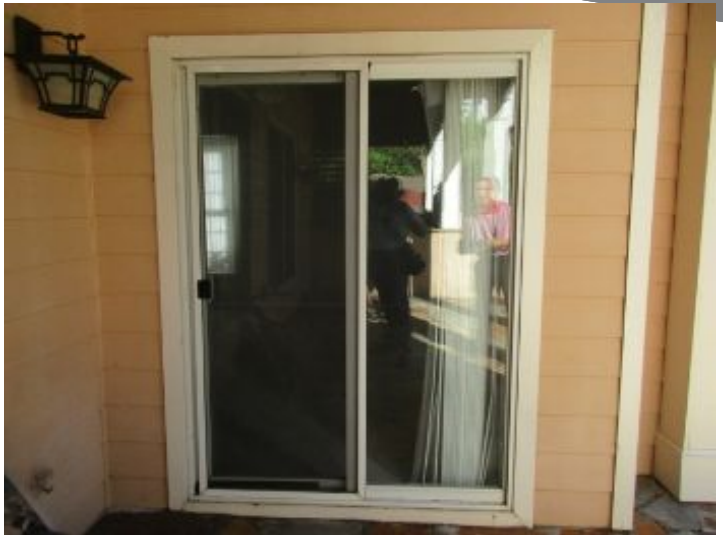
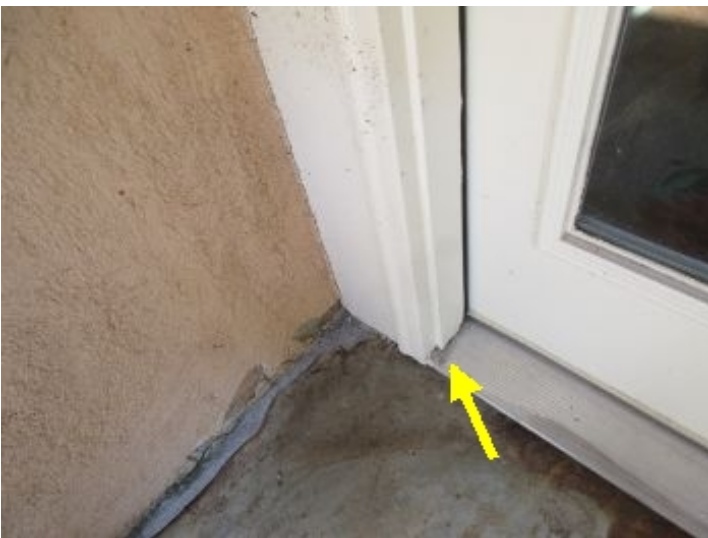
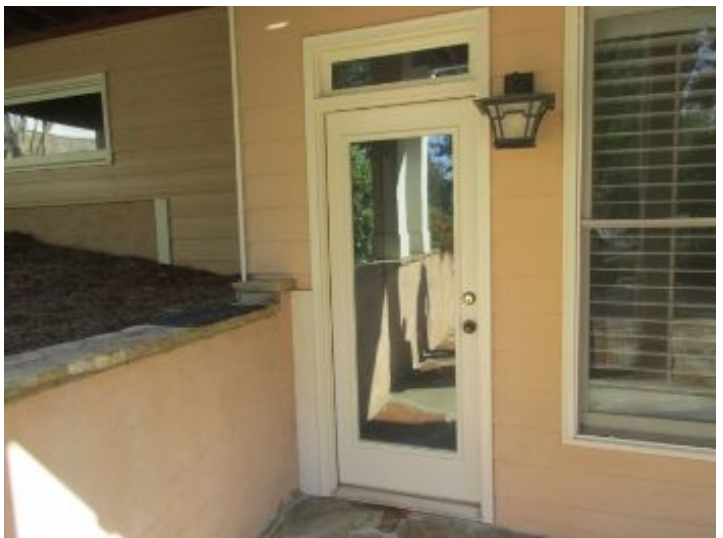
3.1. Repair: Exterior door shows signs of wood rot around the basement doors, repair or replace as needed.

3.2. Repair: Condensation and stains visible on the glass of a double-pane glass on the sliding door in the master bathroom indicated a loss of thermal integrity.

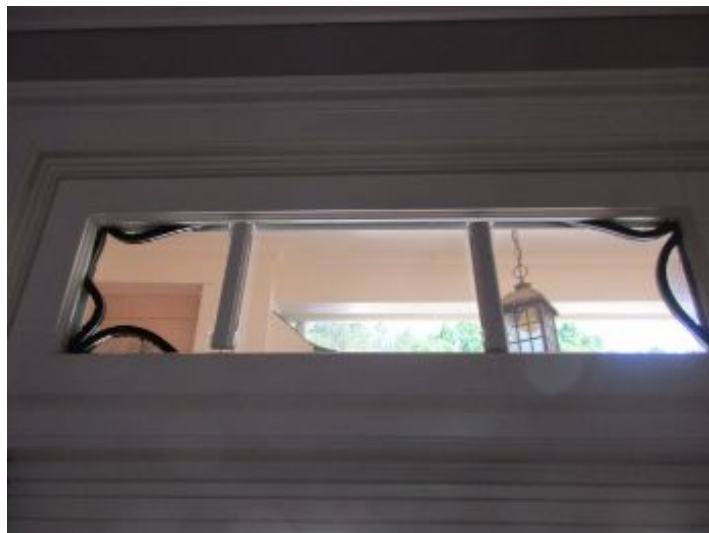
4.1. Repair: Several windows throughout the home has failed seals.

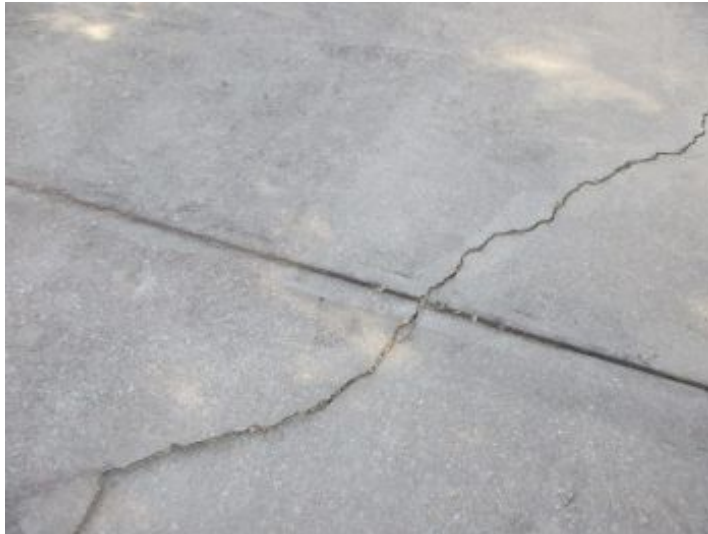
5.1. Improve: Minor cracks in driveway should be sealed to help prevent further deterioration.

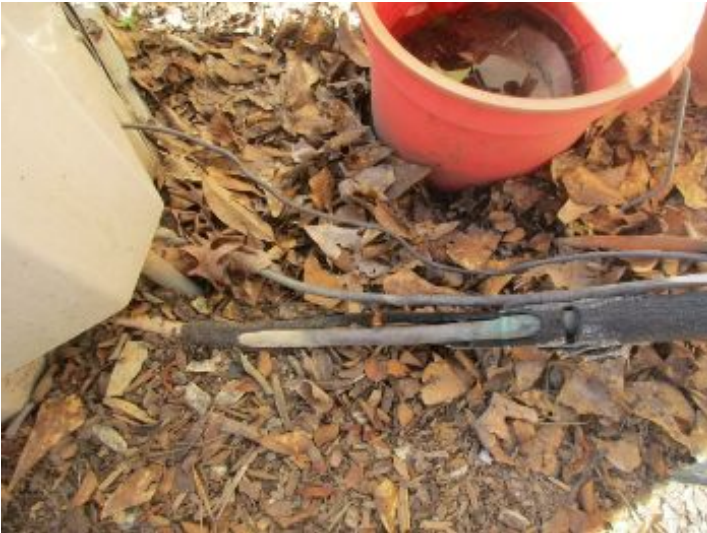
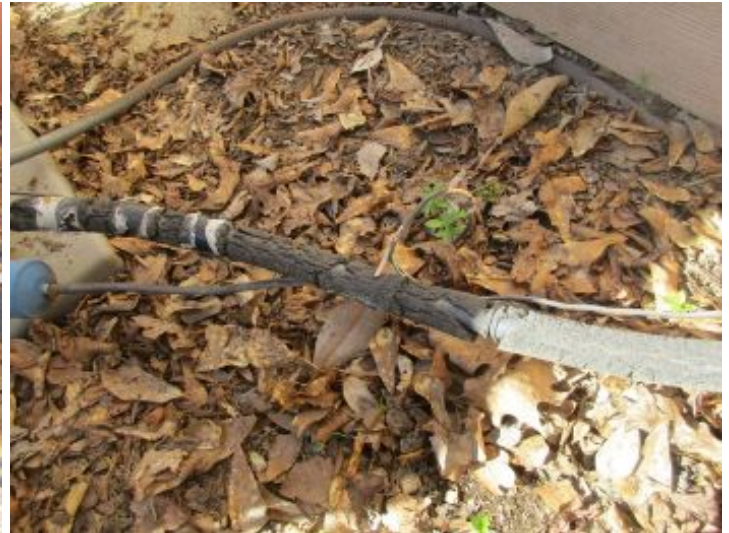
1.2. Repair: Damaged insulation on refrigerant lines should be repaired.

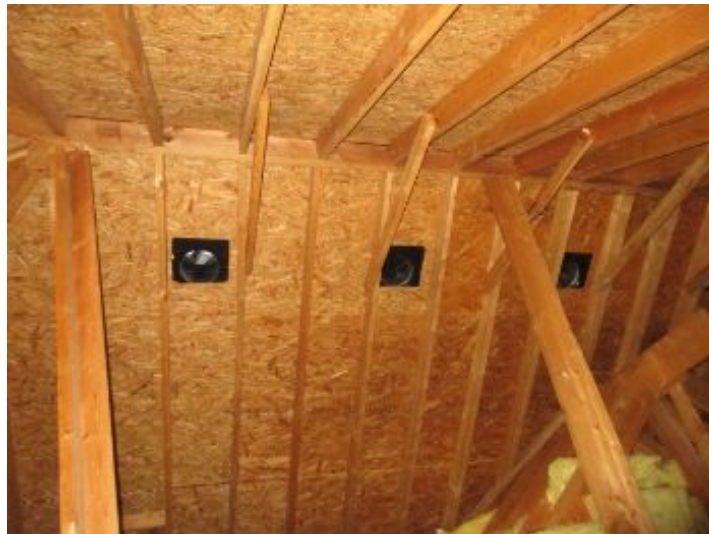
3.1. Repair: Roof vents should be screened to prevent insect and vermin entry.

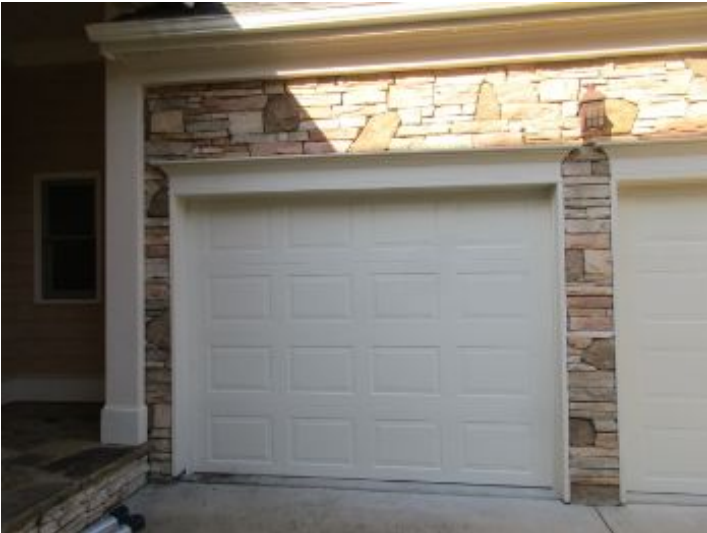
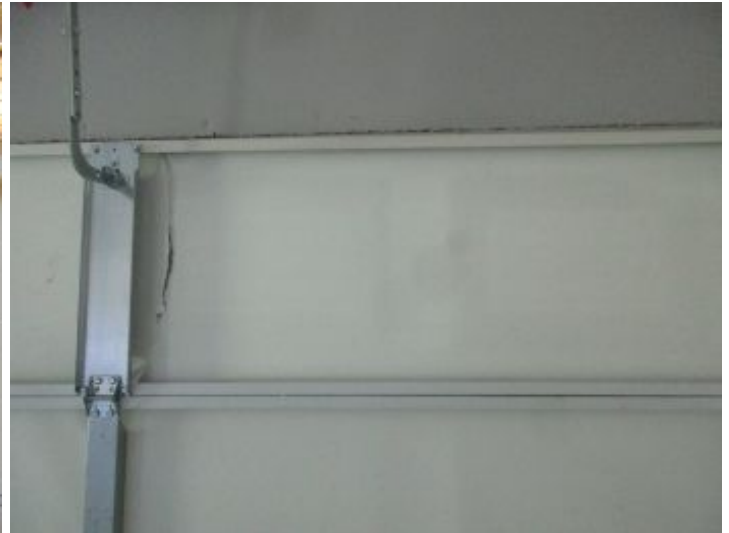
4.2. Monitor: The garage floor slab has typical cracks usually the result of shrinkage and/or settling of the slab. Cracks more than 1/8" high could present a trip hazard.

4.3. Monitor: The overhead garage door insulation was cracked in one of the panels.

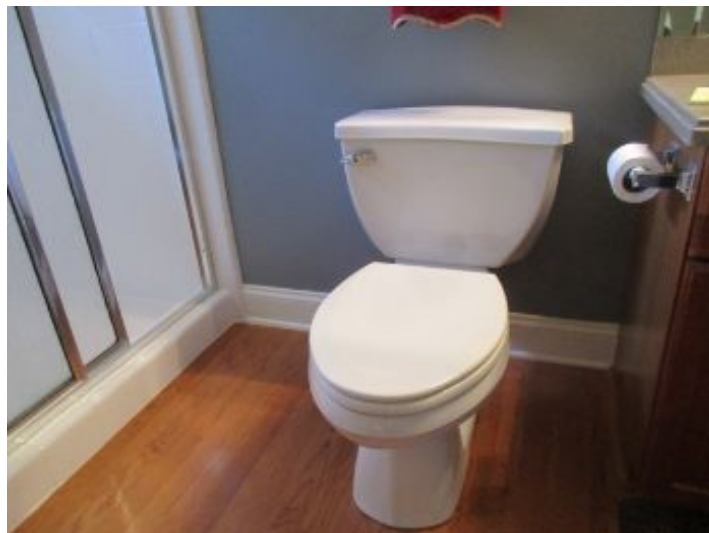
3.1. Repair: The toilet is loose on the main level secure as needed.

3.2. Monitor: The basement shower was observed to drain slowly, suggesting that an obstruction may exist.
